Early detection of dens evaginatus appearing on the premolars and clinical management: histological study

J Clin Pediatr Dent 26(2): 199-201, 2002

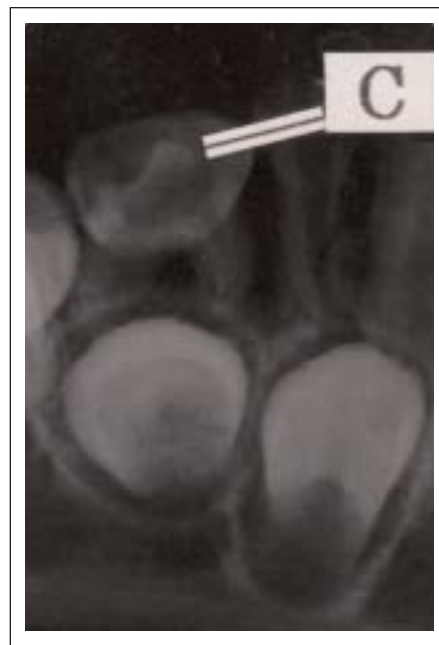
Figure 2. Radiographic appearance on presentation. C: central cusp.

On examination, the tooth had a large central cusp to the upper second premolar (Figure 1). A Radiograph of the central cusp showed a pulpal horn (Figure 2). The central cusp was protected by the application of a self-curing acrylic resin at early detection. Acrylic resin was attached on the occlusal surface for about one year (Figure 3). At one year acrylic resin was observed to the bottom surface and showed good
