Prefabricated Zirconia Crowns – A Solution to Treat Hypomineralized Permanent Molars: Report of a Case

Jorge Casián-Adem*/ Lizette Cobos ** / William F Waggoner ***/ Anna B Fuks ****

A clinical case of a 13-year-old female patient is presented. She had a mandibular second permanent molar that demonstrated significant caries and loss of much of the clinical crown, which was treated with a vital pulpotomy and restored with a prefabricated zirconia crown.

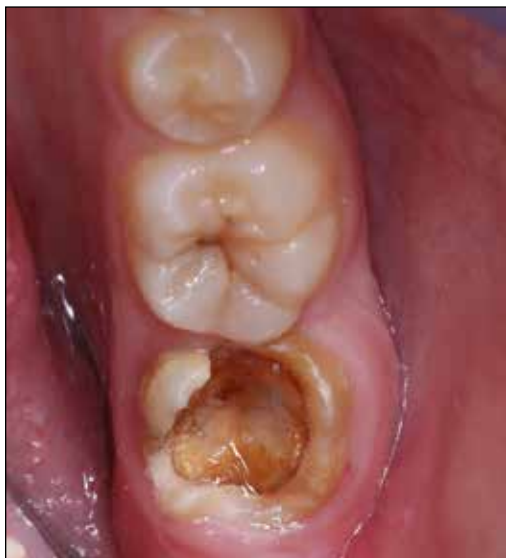
A 13-year-old female patient presented to the office of the principal author(JC) with the chief complaint of an extremely sensitive mandibular right second permanent molar (Figure 1). The patient reported pain caused by temperature changes, particularly cold, which prevented her from chewing any food on the right side of her mouth. Toothbrushing with toothpaste also caused some discomfort; thus, the patient avoided toothbrushing.

The tooth had previously been restored using composite resin restorations, but those restorations had failed and been lost. Clinically, the affected molar exhibited a large, extensive carious lesion and had lost much of the clinical crown.

Figure 1. Initial image of a hypomineralized and carious right mandibular second permanent molar with a very extensive occlusal lesion associated with developmental defects of the enamel.

Due to the extensive carious lesion associated with the MIH and the lack of sound enamel capable of being etched and bonded, a resin restoration was contraindicated. It was decided that full coverage restoration was needed. Historically, preformed metal crowns have been used to restore young, badly broken down permanent molars, but in this instance there was a desire for a more esthetic restoration. It was decided to restore the tooth with a prefabricated zirconia crown (NuSmile ZR Permanent Molar Crown; NuSmile, Ltd., Houston, TX, USA).

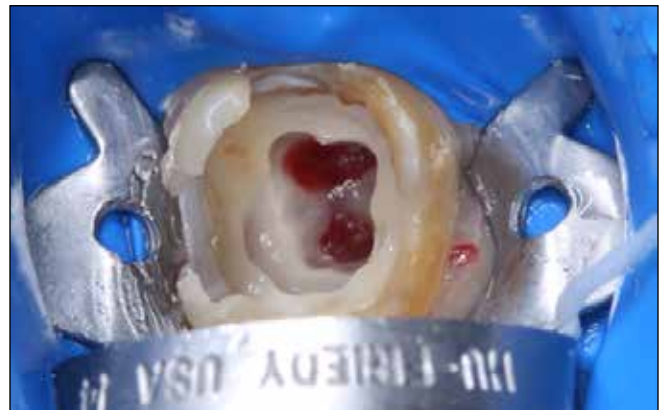
Using a low-speed #6 carbide round bur, the carious tooth structure was carefully excavated. This, however, led to a carious exposure of the pulp, which was found to be vital. As this was a young, permanent molar it was decided to treat the pulp with an MTA vital pulpotomy. (Figure 2).

Figure 2. Occlusal view of the pulpotomy.

The coronal pulp was removed and a wet cotton pellet moistened with a 1.25% solution of sodium hypochlorite was placed on the pulp stumps for approximately 1 min. The pulp chamber was then rinsed with sterile saline solution. A portion of Mineral Trioxide Aggregate cement (NeOMTA; NuSmile, Ltd, Houston, TX, USA) was mixed following the manufacturer’s instructions to a putty-like consistency. The MTA was placed into the pulp chamber with an amalgam carrier and was gently condensed with a wet cotton pellet. The MTA was then covered with a 2-3mm layer of resin-modified glass ionomer cement (BioCem; NuSmile, Ltd, Houston, TX, USA) to protect the MTA during the subsequent process of tooth preparation and crown placement.

The pulp exposure of an immature permanent molar during caries excavation required the decision of either performing a full root canal treatment or a pulpotomy. While the root apices were nearly closed, it was decided that a vital pulpotomy would be the best treatment to maintain vitality and allow for completion of root end closure¹⁵⁻¹⁷.

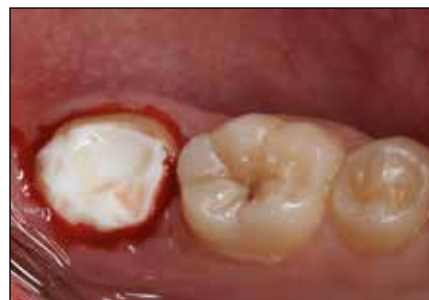
Figure 3. Preparation performed on the mandibular second molar.

Preparation for the zirconia crown was done as conservatively as possible. This consisted of occlusal reduction of approximately 1.5 mm; and circumferential reduction of 1-1.5mm, removing all surface convexity, with a gingival feather-edge margin extending approximately 1.5 mm subgingivally. (Figure 3) As this was a molar in an active process of eruption it was desired to place the gingival margin at a depth that would remain subgingival at the completion of eruption.

Due to the age of the patient, the second molar was still in active eruption. The crown margin was placed approximately 1.5 mm subgingivally in order to compensate for the subsequent eruption of the tooth, yet still maintain a subgingival margin

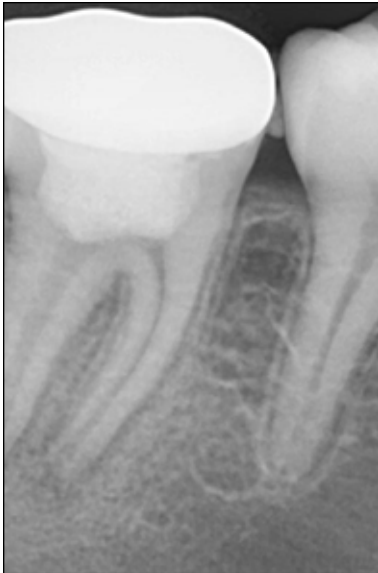
Figure 4. X-ray of the cemented crown. Some excess of cement can be noted on the mesial of the crown.

After fitting the crown to a passive fit, the occlusion was checked, and the crown was deemed ready to cement. Adhesion of resin modified glass ionomer cements to zirconia contaminated by saliva has been shown to be poorer than to non-contaminated zirconia, so prior to cementation the crown was thoroughly rinsed and its inner surface was cleaned with a cleaning solution containing zirconium oxide particles (Ivoclean; Ivoclar Vivadent, Schaan, Liechtenstein) to remove traces of phosphates contained in the saliva that contaminated the crown during try-in. (It should be noted that the NuSmile Permanent Crown kits now come equipped with pink “try-in” crowns which can be used to trial fit the prefabricated zirconia crowns, avoiding the contamination of the zirconia crowns to be cemented.) The crown was then cemented with resin-modified glass ionomer cement (BioCem; NuSmile, Ltd, Houston, TX, USA) following the manufacturer’s instructions. A post-operative radiograph was taken to evaluate the final fit and cementation. Excess retained cement was noted on the radiograph and removed. The fit of the crown and evaluation of the pulpal treatment was found to be very satisfactory. (Figure 4).

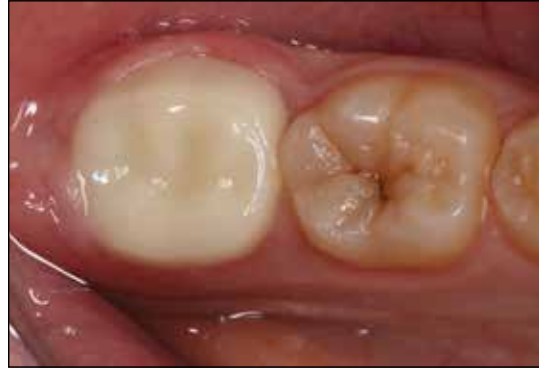
One week later the tooth was reassessed. Tooth sensitivity had completely disappeared, the gum around the crown was healthy, and the patient was very pleased with the treatment, reporting that she was able to eat, chew, and brush her teeth in a normal manner (Figure 5).

Figure 5. Photograph of the crown 1 week after cementation. The crown appears clean, the gingival tissue is healthy, and tooth sensitivity has disappeared.

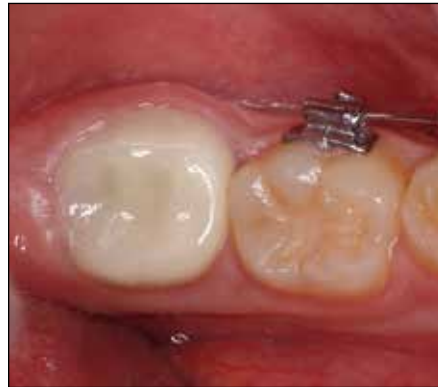
Fourteen months later, the patient initiated orthodontic treatment in the same dental office, allowing for continued follow-up of the tooth. At 40 months post-operatively the crown had retained its esthetics and function and the tooth had remained vital and asymptomatic. (Figures 6 and 7)

Figure 6. Follow-up at 40 months after crown placement. The tooth is asymptomatic and the gingival tissue appears healthy.

Forty months after restoration the molar was asymptomatic; and clinically and radiographically sound with an esthetic appearance. Both clinical and radiographic monitoring is ongoing to evaluate the continued vitality and clinical function of the crown. Zirconia is extremely durable and biocompatible, and the post-operative radiographs show good marginal adaptation of the crown. Replacement of this pre-fabricated crown with a custom crown may be necessary in the future, but that decision will be dictated only if failure of the present treatment occurs.

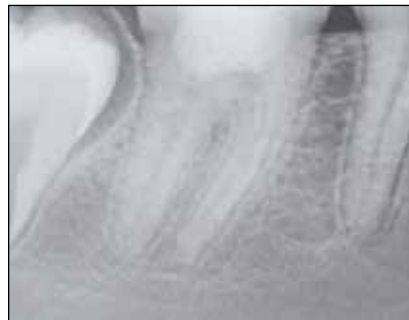
Figure 7. Periapical control x-ray 40 months post-op.
