Resin bonded metal plate as a splint for fractured restored teeth: a case report

This article presents a case with traumatic tooth fracture that was treated by direct pulp capping followed by fragment restoration. The fixed parts were reinforced by resin bonded metal plates.

J Clin Pediatr Dent 28(3): 199-202, 2004

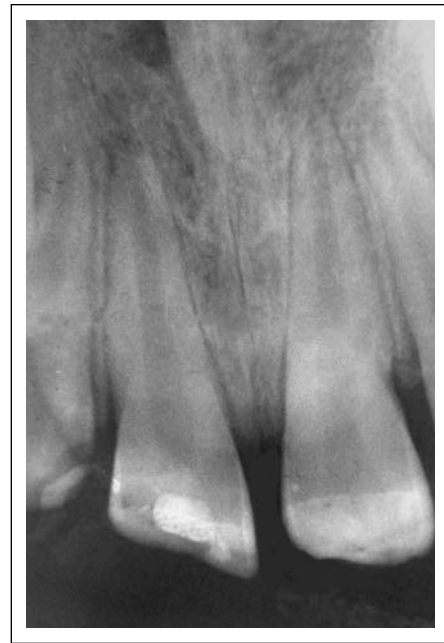
Figure 1. Radiographic image of fractured teeth after direct pulp capping. Note the immature roots.

The elapsed time since the trauma was about two hours. Clinical and radiographic examination did not reveal any root fracture (Figure 1). Fortunately the patient had found and saved the fractured segments. Local anesthesia with lidocaine (2%) was used to control the pain. The teeth were isolated by cotton rolls and were rinsed with saline solution gently. Because the time elapsed after exposure was not long and the exposures were small, direct pulp capping was chosen to preserve vital pulp tissues, because the roots were not mature.

The exposed areas were covered with calcium hydroxide paste (CaOH-Plus, Roeko, Germany) and fractured parts were attached by Panavia EX (Kurary, Osaka, Japan) resin cement, but due to excessive bite force the fractured parts were detached 3 times during

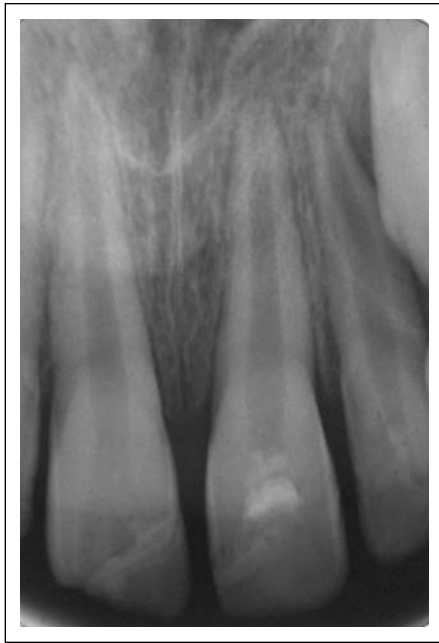
Figure 2. Radiographic image of anterior teeth after fractured restoration. (one month after fracture)

1 year of follow up. Vitality tests revealed pulp vitality and root maturation was shown in radiographic examination. (Figure 2)

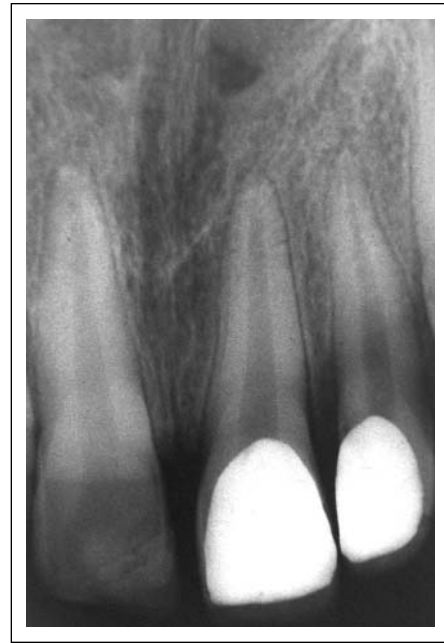
Figure 3. Radiographic image of restored teeth with metal plates. Note the root maturation. (23 months after fracture and 12 months after the metal plates were cemented)

5. An impression was made by an elastomeric impression material (Impregum F; ESPE America Inc, Norristown, Pa.) and poured with stone die material. Wax patterns were made on the prepared dies and were cast in a base metal alloy (Supercast, Termabond Alloy Mfg.). The plates were sand-blasted, cleansed in an ultrasonic bath and etched with electrochemical etching for 3 minutes (300 mA/cm², 3 Volts) in a 10% sulfuric acid solution. They were cleansed with 18% hydrochloric acid (HCl) for 10 minutes. Finally the plates were rinsed with tap water and dried for cementation. One can utilize other metal surface treatment methods such as perforation, salt crystal, sand blasting and so on according to availability of equipments and materials.

6. The teeth were isolated with a rubber dam; pumice powder and alcohol mixture was applied with a prophylaxis brush on the prepared tooth surface for cleansing. The teeth were etched with 37% phosphoric acid gel (Tooth Conditioner Gel, Dentsply Caulk, Milford, DE) for 1 minute, dried with air gently. The prepared metal plates were cemented to the prepared teeth by a dual cure composite resin cement (Enforce, Dentsply Caulk, Milford, DE) as recommended by the manufacturer. The composite excessive cement was removed after curing was completed and the occlusion was checked for any interference. The final finishing and polishing must be accomplished after 24 hours for complete polymerization of the resin. (Figures 3, 4, 5)

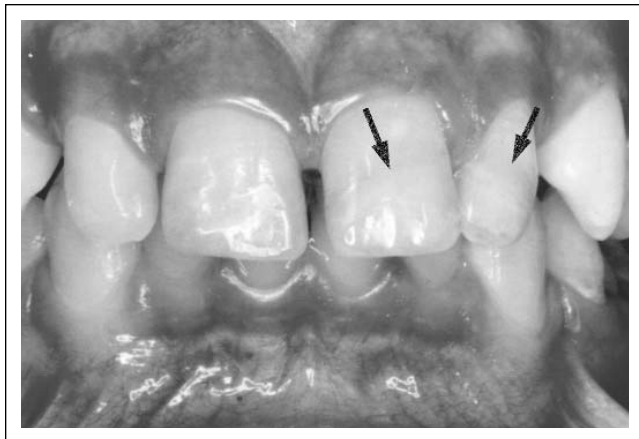
Figure 4. Anterior view of restored teeth (11, 21 and 22). Note the fracture line (arrows) and the deep overbite.

1. The fractured parts were attached by dual cure composite resin cement (Enforce, Dentsply Caulk, Milford, DE).
2. A circumferential bevel with 0.25-0.5 mm depth and 0.5-1 mm width on the fracture line (on both parts) was made by a bud shape diamond bur with 1.5-2.0mm head diameter. In most cases the proximal areas must be omitted because it can damage adjacent teeth.

3. The prepared groove was filled with a filling composite resin to enhance retention of the fractured parts, so during the clinical and laboratory procedures, the restored parts remained attached.

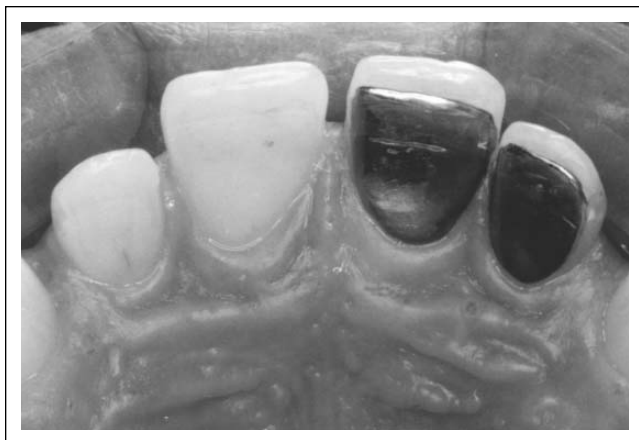
Figure 5. Palatal view of cemented metal plates on teeth 21, 22.

4. Palatal surface of the restored teeth were reduced 0.3-0.5mm to provide sufficient space for the metal plates and prevent over contouring and occlusal interference. A shallow chamfer gingival finishing line was placed 0.5mm supragingivally and a shallow groove was prepared all around the area that must be covered by the plate to determine the finishing line for the metal plate extension for the technician. Overextension in the incisal area must be avoided because the gray shade of metal will be shown through the transparent incisal enamel.
